NATIONAL PROGRAM FOR INSPECTION OF NON-FEDERAL DAMS
LAKE DAWSON DAM (CT 0. (U) CORPS OF ENGINEERS WALTHAM
MA NEW ENGLAND DIV AUG 79

LAKE DAWSON DAM
CT 00018

PHYSICAL INSPECTION REPORT
LAKE DAWSON PROGRAM

AUGUST, 1979

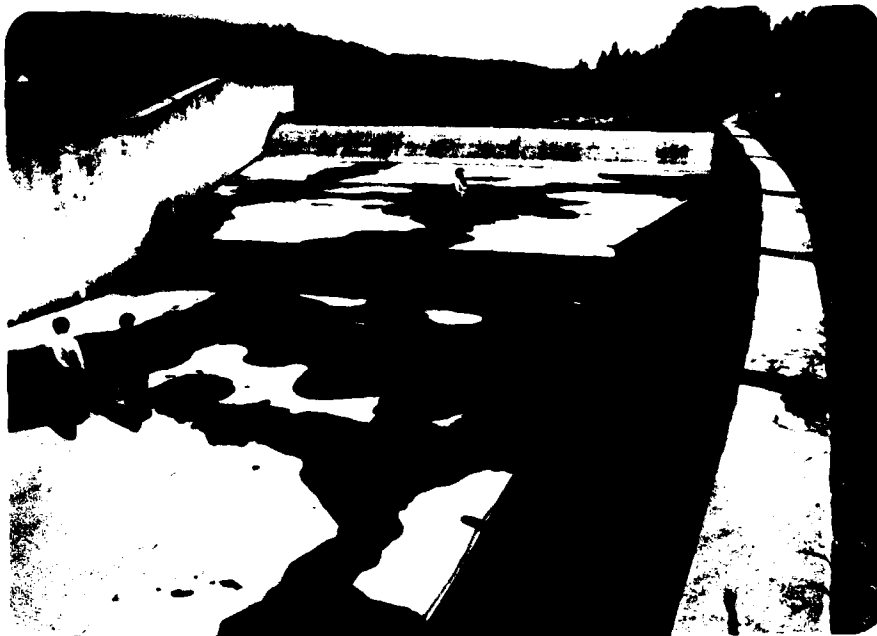
PHOTO 7 - General view of spillway channel and weir from downstream.
